Group Chairman's Factual Report

Engineering

*S/S Norway* Boiler Rupture

Accident Number: DCA-03-MM-032

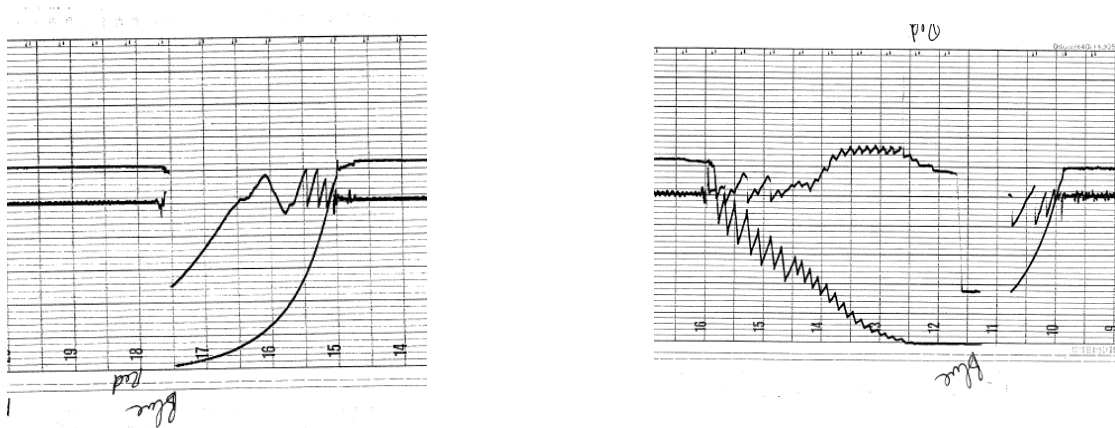
**Figure 4 - Pressure-Time Strip Charts – cool down (left chart) and warm up (right chart)**

c) Chart recorders. As mentioned in the boiler description section of this report, the boiler monitoring system had several strip chart recorders<sup>66</sup> that recorded various boiler operating parameters, such as drum level, superheat temperature and steam pressure. The chart recorder that recorded the boiler pressure indicated the pressure of the boiler over time, and could be used to estimate the time warm up and cool down times during light-off and shut down evolutions. In the charts shown here, the elapsed time is on the horizontal axis and the value of the measured parameter is on the vertical axis. Each vertical line on the time scale was thirty minutes, and each hour was marked by a number, although the numbers did not necessarily correspond to the actual time of the recording. For example, the elapsed time between 16 and 17 was 1 hour, but 16 did not represent 1600 hours. The chart recorder's paper advance rate was tested and verified after the accident. Examination of several charts revealed similar pressure-rise and pressure-fall profiles during light-off and shut down evolutions. Light off profiles were consistent with intermittent firing of the boiler, and resembled a saw-tooth shaped curve. Shutdown profiles indicated a steadily decreasing curve, with the slope of the curve indicative of the rate of pressure fall with respect to time. The charts generally revealed that during light-off, pressure on the boilers was raised from zero to full pressure in about four hours; and during shutdown, pressure was reduced from full pressure to zero pressure in about three hours.
